### **State Project No. 103-TBD (*Temporary*) Rehabilitation of the Sunnyside Street Bridge over Yantic River**

**BRIDGE NO. 04746**  
**SUNNYSIDE STREET OVER YANTIC RIVER**  
**NORWICH, CONNECTICUT**  
**SEPTEMBER 24, 2008**  
**(LAST DAY OF INSPECTION APRIL 7, 2009)**

## IN-DEPTH INSPECTION

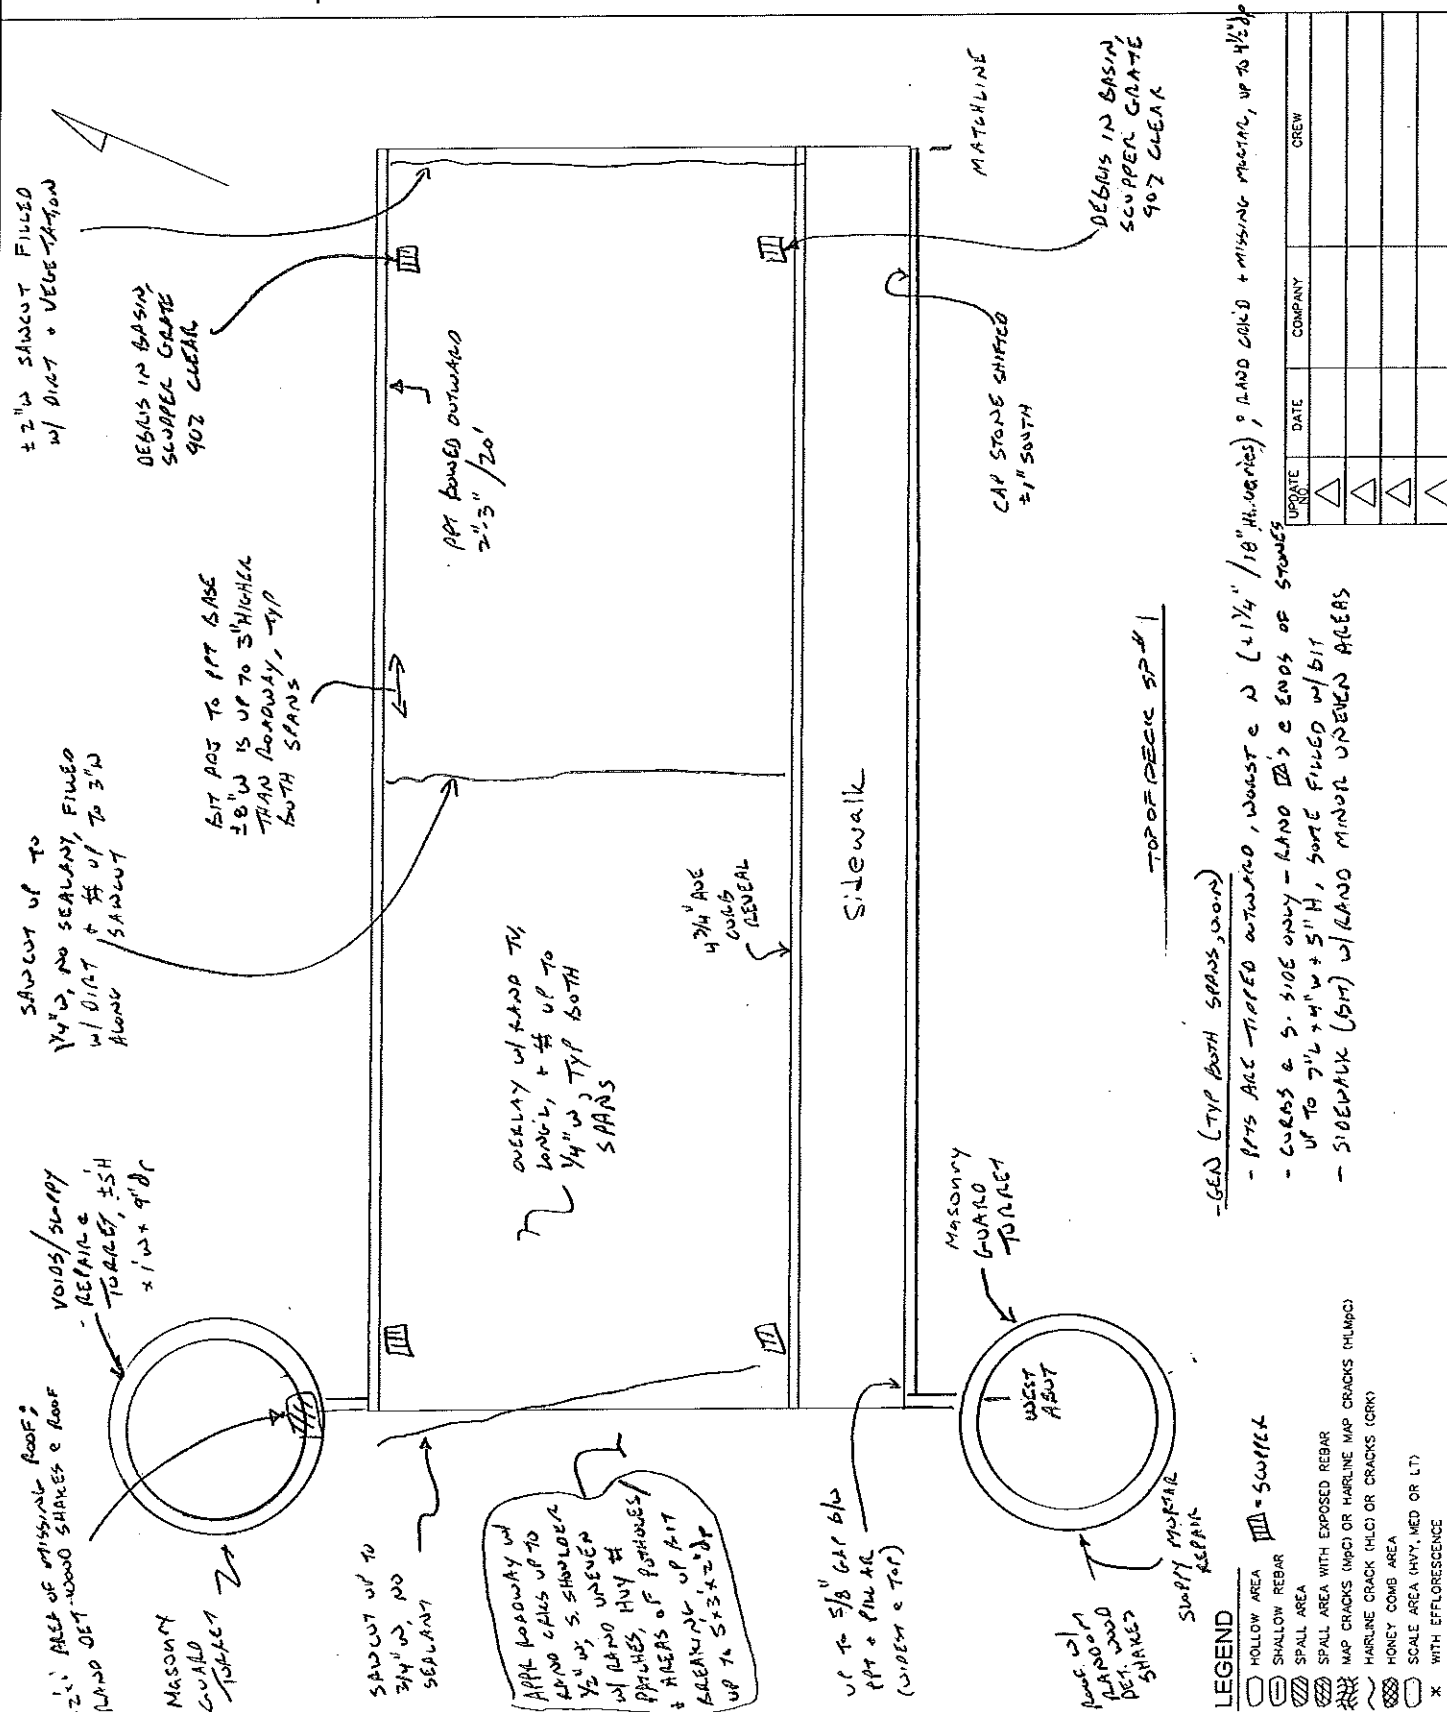
SHEET 11/41

The bituminous overlay has random transverse, longitudinal, and map cracks up to 3/8" wide. Isolated cracks are up to 3/4" wide. The bituminous adjacent to the base of the north parapet is approximately 3" higher than the roadway surface approximately 8" away. There are random sawcuts in the overlay up to 2" wide that are filled with dirt and/or vegetation. No sealant was seen along these sawcuts. See sheets 11-12 and photos 9 - 11.

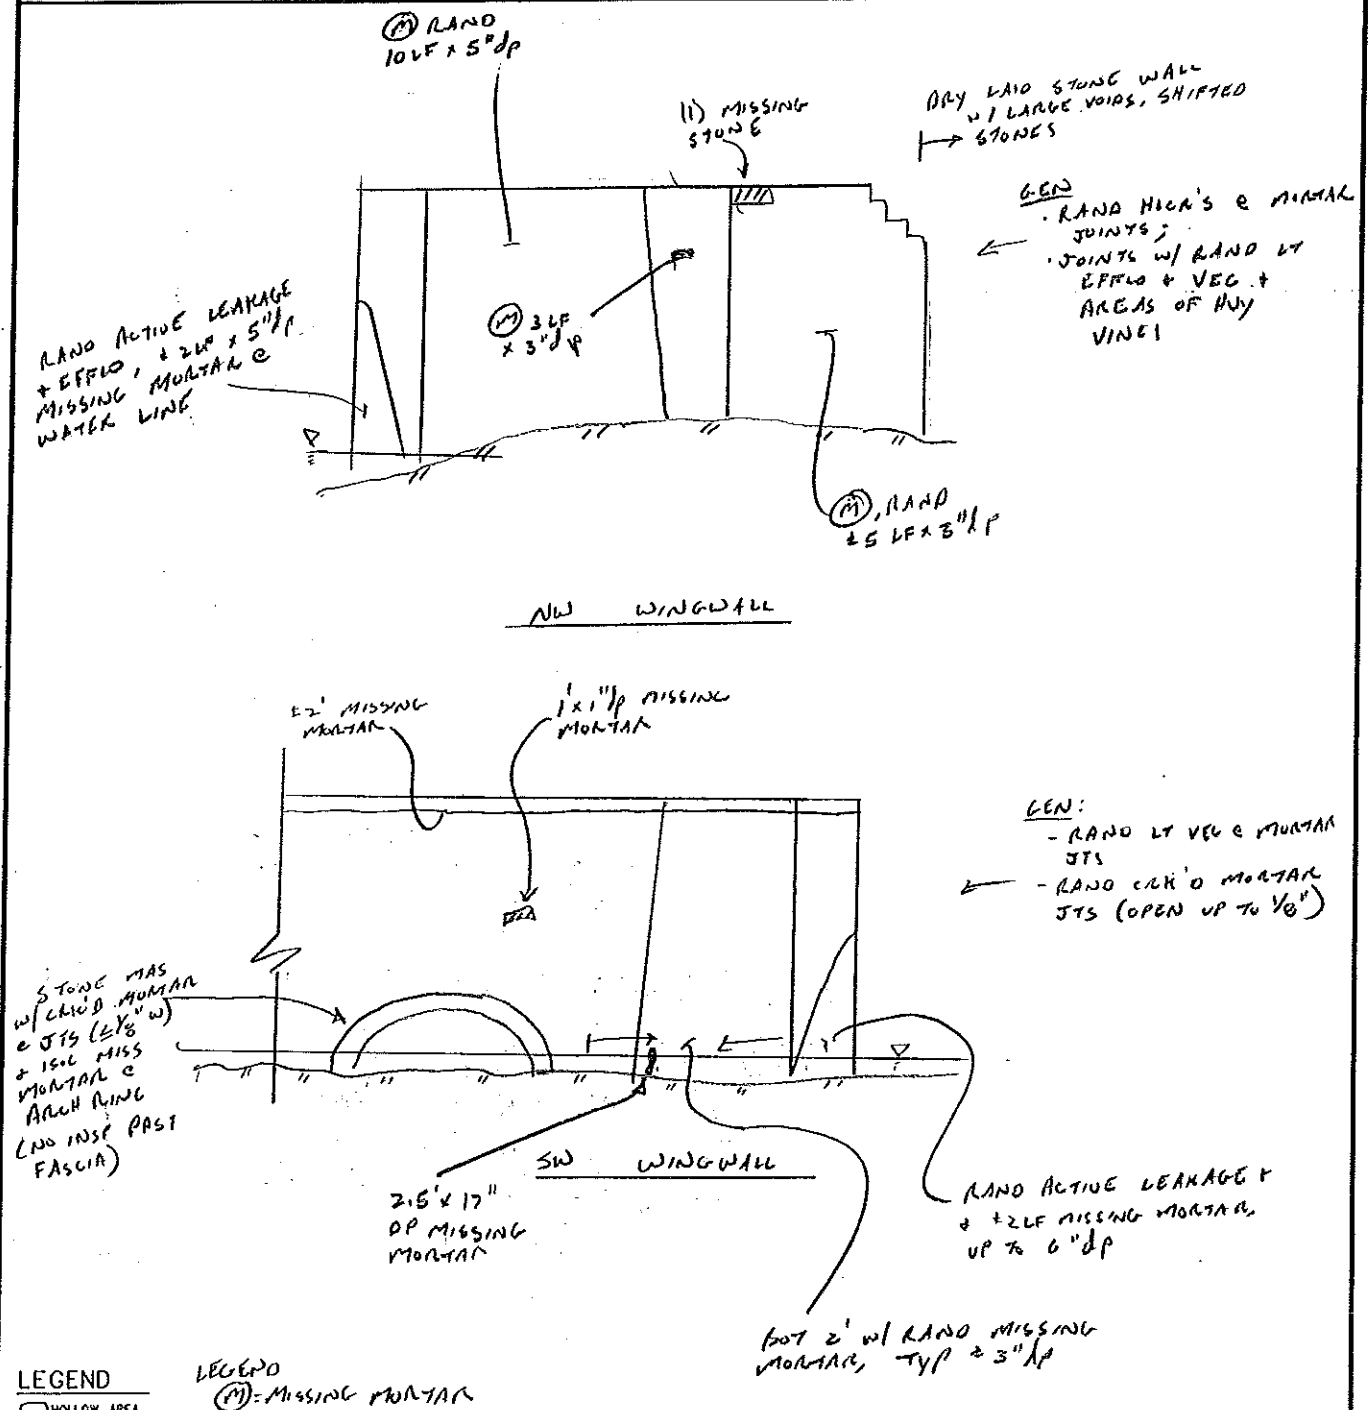
SHEET 19 OF 41

North retaining wall between spans 1 & 2 is tipped outward, approximately 1.5" over a height of 2.5'. Additionally the northeast wingwall has stones that are settled and laterally displaced up to 4.5". Previous 8" settlement noted at this location actually appears to be uplift of a concrete pour on top of the wall due to tree root growth just under this concrete pour. See "Embankment Erosion" item under Item 61 for the condition of the retaining walls along the channel. See sheets 19-22 and photo 19.

Stone masonry wingwall mortar joints have random cracks up to 1/8" wide, random deteriorated mortar up to 5" deep, and random vegetation/vine growth. The northwest wingwall has one missing cap stone. The southwest wingwall has a stone arch for a raceway/stream. The northeast wingwall has two cracked stones, one up to 1/4" wide. In addition, the northeast wingwall has stones that are settled and laterally displaced up to 4.5", creating voids up to 2" wide x 15" deep. The southeast wingwall has one stone that is pushed out 1/2", an area of mortar pushing out, and a 1' x 6" x 7" deep void. See sheets 19-22 and photos 19-21.

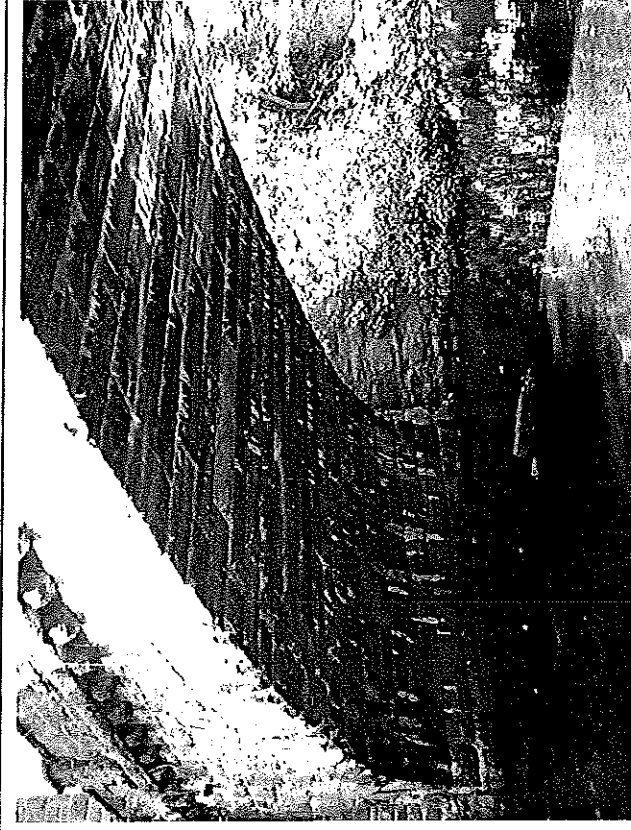
Photo # 4: Typical underside, span 1 (looking west).

Note the efflorescence leakage at the mortar joints.

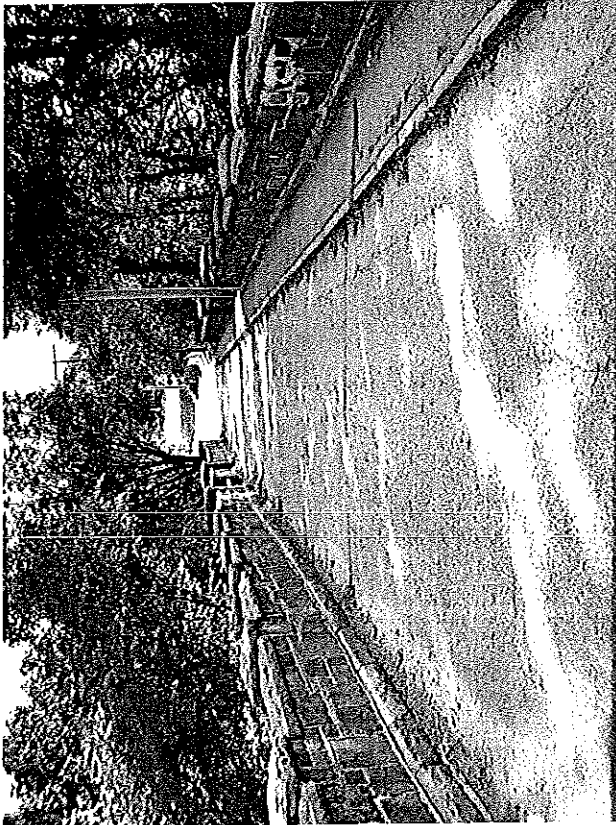
South side only: There are random spalls at the edges of the granite stones, up to 7" long x 4" wide x 5" high. Some spalled areas are filled in with bituminous. Random mortar joints are cracked or deteriorated. Average curb reveal was found to be 4.75". See sheets 11 & 12 and photo 9.

| <p>Photo # 9: Typical top of deck.</p> | <p>Photo # 10: Bridge overlay ramps up approximately 3" near the base of the north parapet.</p> |

1. Seal the cracks and the sawcuts in the overlay ( $\pm 600$  linear feet).
2. Repair corner spalls in the granite curbs ( $< 1/4$  cubic yard).
3. Repair deteriorated mortar joints along the parapets ( $\pm 250$  linear feet).
4. Continue to monitor the tipping of the parapets.
5. Repair deteriorated roof shakes (as required) and missing section of roof sheathing ( $\pm 2$  square feet) at the guard turrets.

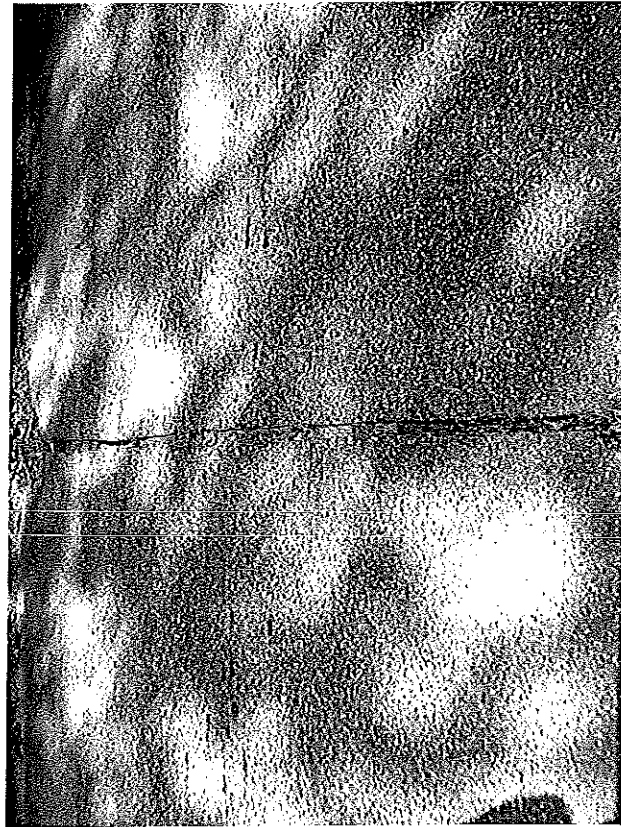
Photo # 11: Typical sawcut in the bridge overlay. Note that there is no sealant. Sawcuts are filled with dirt and have random vegetation.

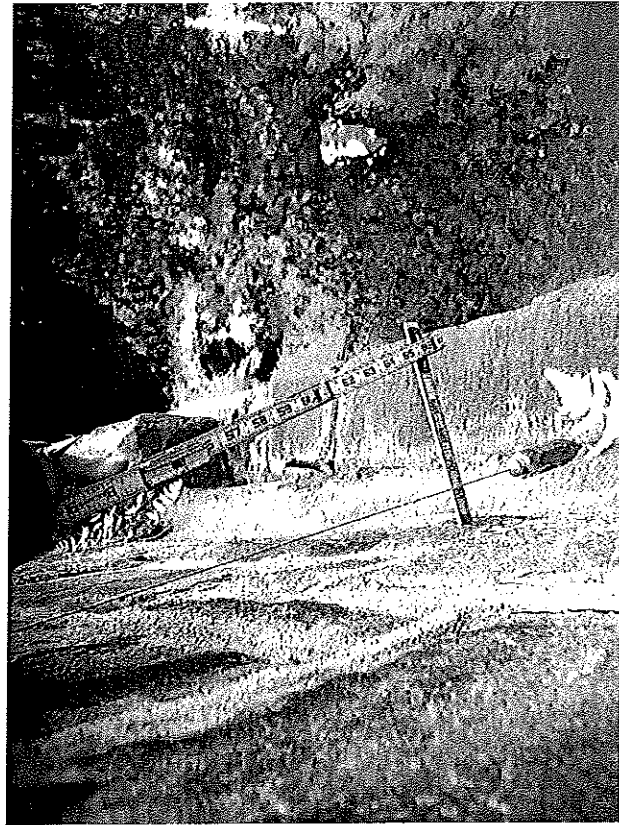
Stone masonry parapets: Stone masonry parapets have random cracked mortar joints, up to 3/16" wide, and areas of missing mortar, up to 4.5" deep. Mortar deterioration is worst at the outside faces of the span 1 parapets, where approximately 60% of the mortar joints are deteriorated. A capstone at the south parapet in span 1 is shifted south 1". The previously reported 3/8" gap between the parapet and the pillar at the southwest corner of the bridge is open up to a maximum of 5/8". The parapets are tilted outward, up to 1.25" over 1.5'. Additionally, the north parapet at the east end in span 2 appears to be bowed/distorted outward 2" - 3" over a length of 20'. See sheets 11-12 and photo 12.

Photo # 12: Tipping of the north parapet.

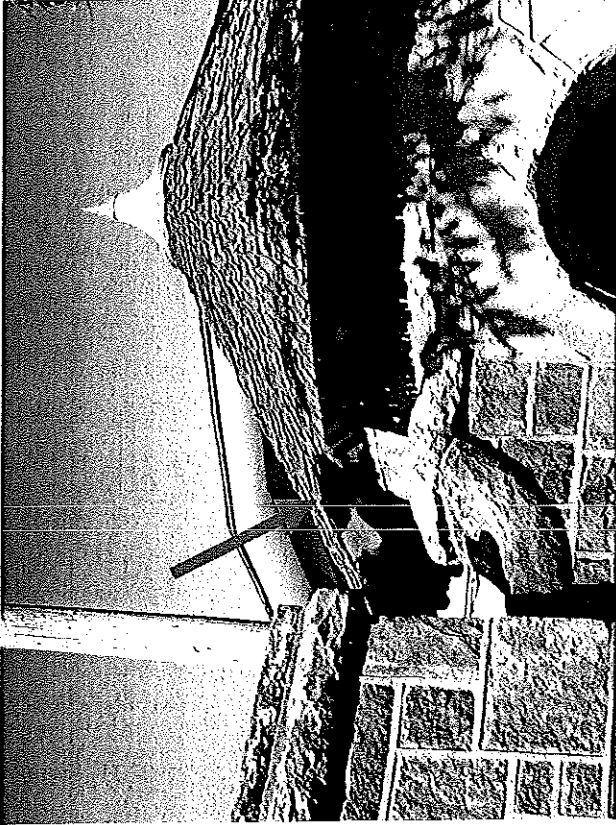
Stone masonry guard turrets at west approach: The north turret has a 2' x 1' missing section of roof. There are random deteriorated shakes along the roofs. There are sloppy mortar repairs at each turret, up to 5' high x 1' wide x 9" deep. There is random graffiti inside of the turrets. See sheets 11-12 and photos 5 & 13.

| <p>Photo # 13: North guard turret: Missing section of roof at the south side of the turret.</p> | <p>Photo # 14: East end of span 1: Areas of heavy efflorescence and areas of water leakage through the arch intrados.</p> |

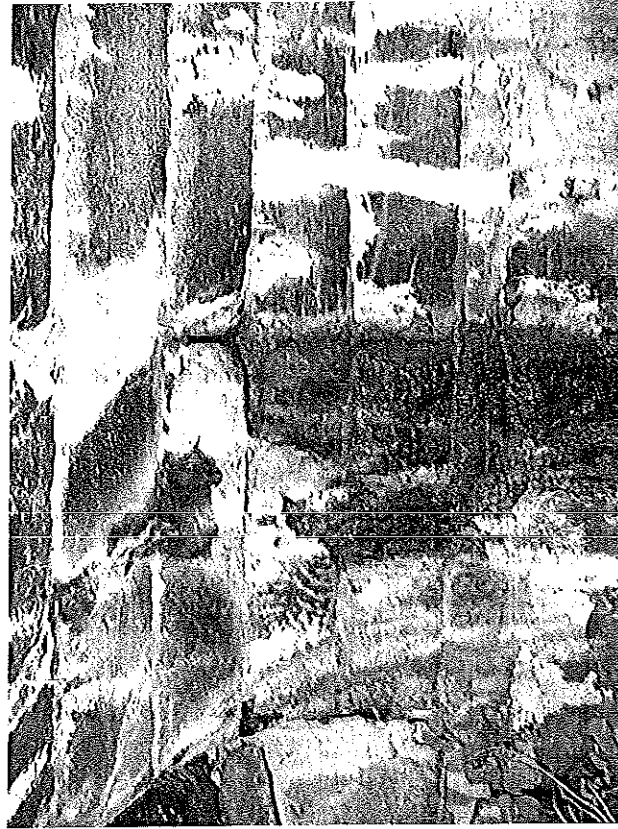
Photo # 15: East end of span 2: Heavy efflorescence and water leakage through the arch intrados.

1. Repair the areas of mortar loss along the intrados and spandrels ( $\pm 150$  linear feet).
2. Consider removing heavy efflorescence from the ends of the spans to inspect mortar at the intrados.

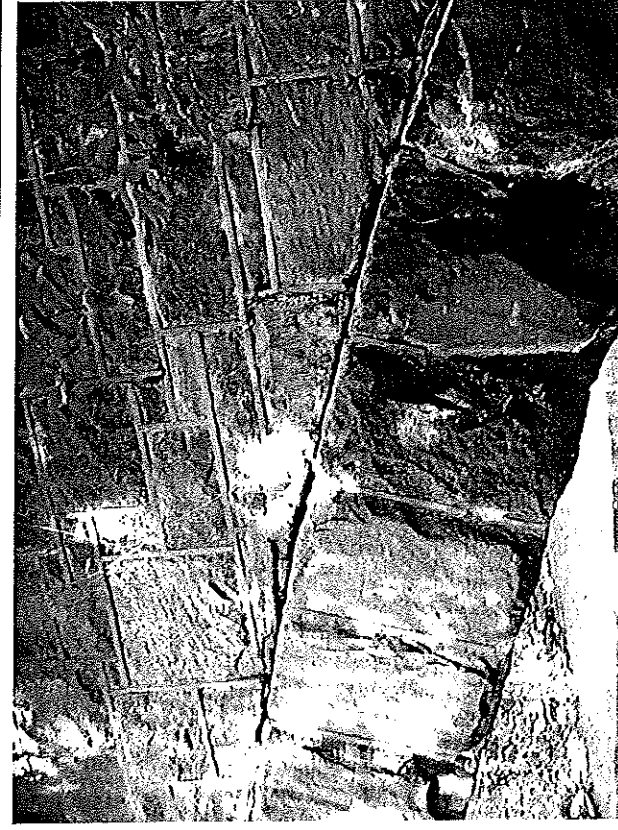
| | RATING | |
|---|---|---|
| STRINGERS | 6 | <p><b>Intrados:</b><br/>There are areas of heavy efflorescence along the mortar joints throughout in each span. There are also areas of water leakage at random areas, mostly at the lower sections of the arch (as opposed to the crown area). Random mortar joints are cracked up to 1/16" wide. There are isolated areas of missing mortar in span 1 up to 2" deep. The transverse mortar joint along the crown in span 2 has missing cracked mortar (<math>\pm 1/8</math>" wide) along the north half of this joint and deteriorated/missing mortar up to 1" deep along the south half of this joint. Random areas of previously noted missing mortar may have been hidden by heavy efflorescence accumulations. Also, there are random repairs to the mortar joints, some of which appear recent. See sheets 13-18 and photos 4, 14, &amp; 15.</p> <p><b>Spandrels:</b><br/>Stone masonry spandrel walls have random cracks along the mortar joints, up to 1/8" wide, and random areas of missing mortar up to 4" deep. The span 1 south spandrel has an isolated cracked stone and small stone spall. The mortar joints between the arch ring and the span 1 spandrel bases are deteriorated throughout. These mortar joints have cracks, punky areas, missing mortar up to 4" deep, and areas of loose/pushing out mortar throughout. These same mortar joints in span 2 have cracks up to 1/8" wide, random light efflorescence, and random hollow and deteriorated mortar up to 2" deep. See sheets 13-18 and photos 16 &amp; 17.</p> |

Photo # 16: Span 1, south elevation, east end: Deteriorated mortar between the arch ring stones and the spandrel wall.

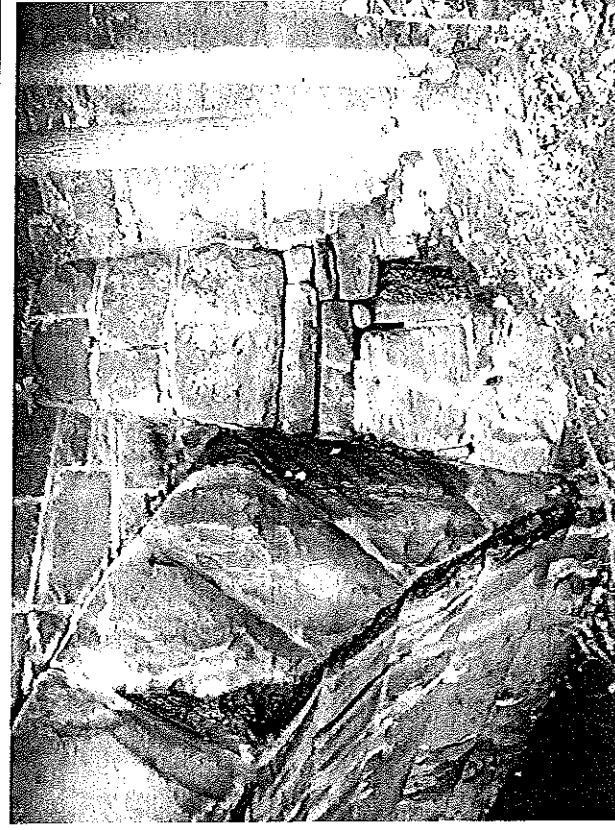
There are areas of missing mortar up to 6" deep and water leakage. There treatment at the northeast corner of span 1 has up to 50% deteriorated, mortar and one stone is loose due to deteriorated mortar. See sheets 19-22 and photo 18.

Photo # 18: Span 1, southeast corner: Architectural stone treatment at the corner of the span has deteriorated mortar/voids between the stones. Also note the leakage through the arch ring.

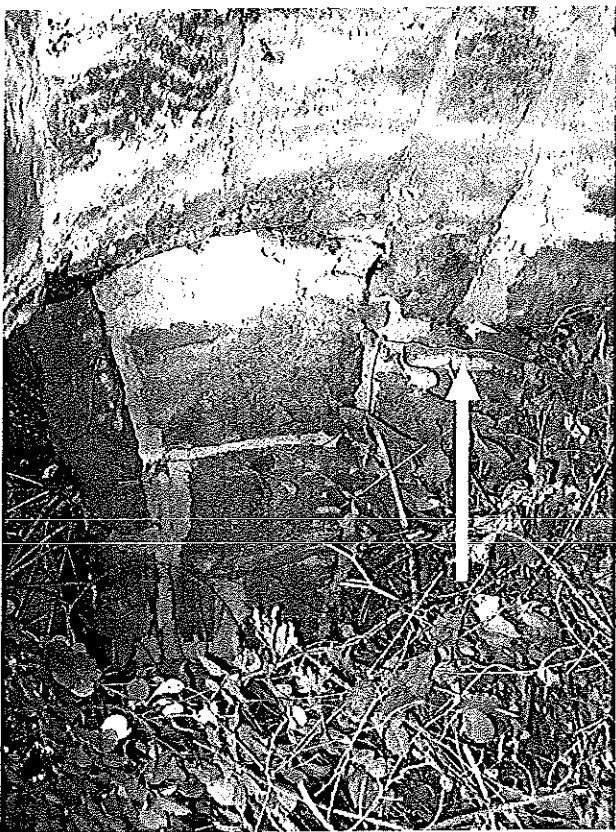
| <p>Photo # 19: Northeast wingwall: Stones shifted out at the base.</p> | <p>Photo # 20: Southwest wingwall. Note the stone arch in the wingwall.</p> |

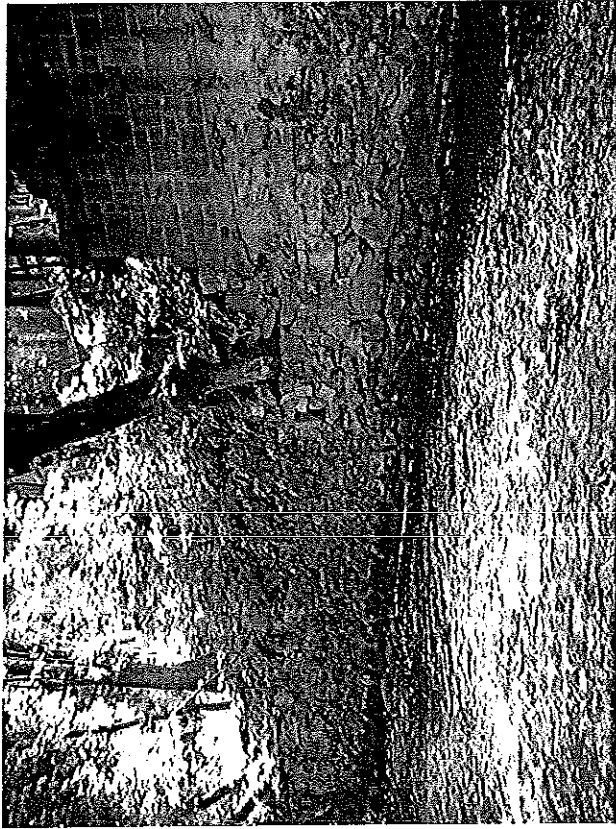
| <p>Photo # 21: Southwest retaining wall: Shifted stones and tree growing out of the wall.</p> | <p>Photo # 22: Stone masonry wall between spans 1 &amp; span 2, north elevation.</p> |

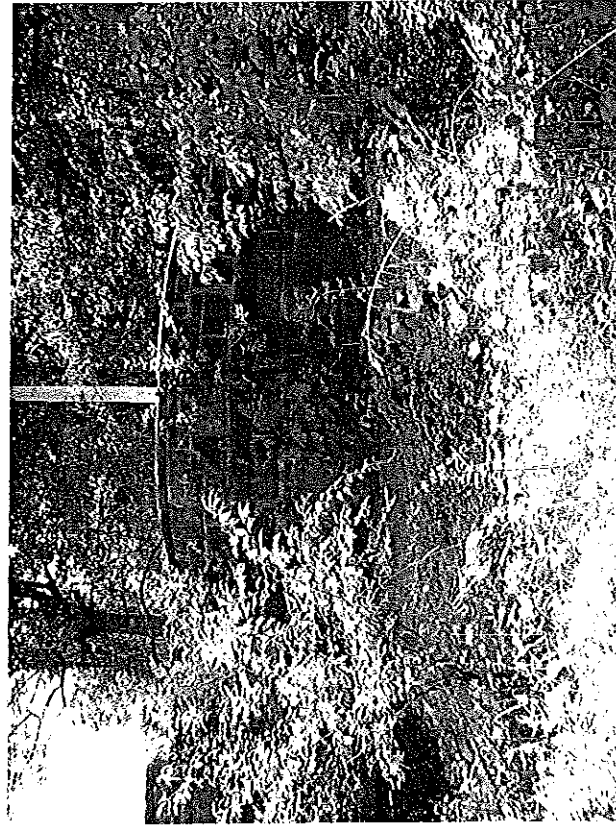
Wall at the north elevation is tipping outward, approximately 1.5" over a height of 2.5'. There are two full height x 1/8" wide cracks along the mortar and isolated missing mortar up to 6" long x 3" deep. The wall at the south elevation was almost completely covered and/or inaccessible due to heavy vegetation at the time of inspection. Accessible areas of this wall have random cracked and deteriorated mortar. See sheets 19-22 and photo 22.

1. Repair deteriorated mortar joints ( $\pm 50$  linear feet).
2. Fill in undermined area along the west abutment with suitable material ( $< 1/4$  cubic yard).
3. Continue to monitor tipping of the retaining wall at the north elevation.

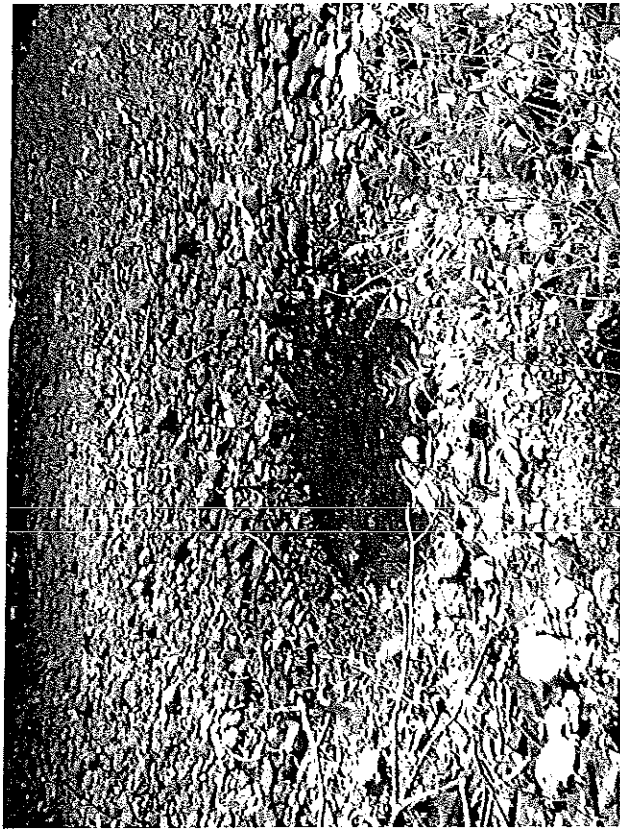
Photo # 25: Scour hole at the southeast channel embankment.

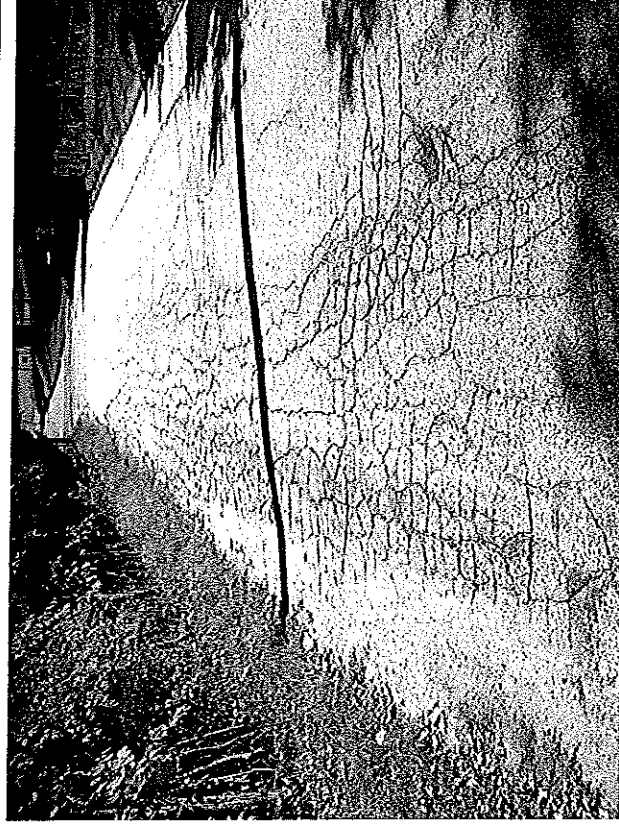
East approach: The east approach pavement has heavy map cracking up to 5/8" wide, random areas of up to 1.5" settlement in the shoulders, and isolated potholes/breaking up bituminous up to 8" x 9" x 1" deep. There are also random patches. See sheets 11-12 and photo 26.

Photo # 26: East approach pavement with heavy cracking.

1. Repair deteriorated bituminous at the southwest approach ( $< 1$  ton).
2. Consider installing approved guide railing at the east approaches ( $\pm 50$  linear feet).
