### **State Project No. 103-TBD (*Temporary*) Rehabilitation of the Sunnyside Street Bridge over Yantic River**

**BRIDGE NO. 04746**  
**SUNNYSIDE STREET OVER YANTIC RIVER**  
**NORWICH, CONNECTICUT**  
**SEPTEMBER 24, 2008**  
**(LAST DAY OF INSPECTION APRIL 7, 2009)**

## IN-DEPTH INSPECTION

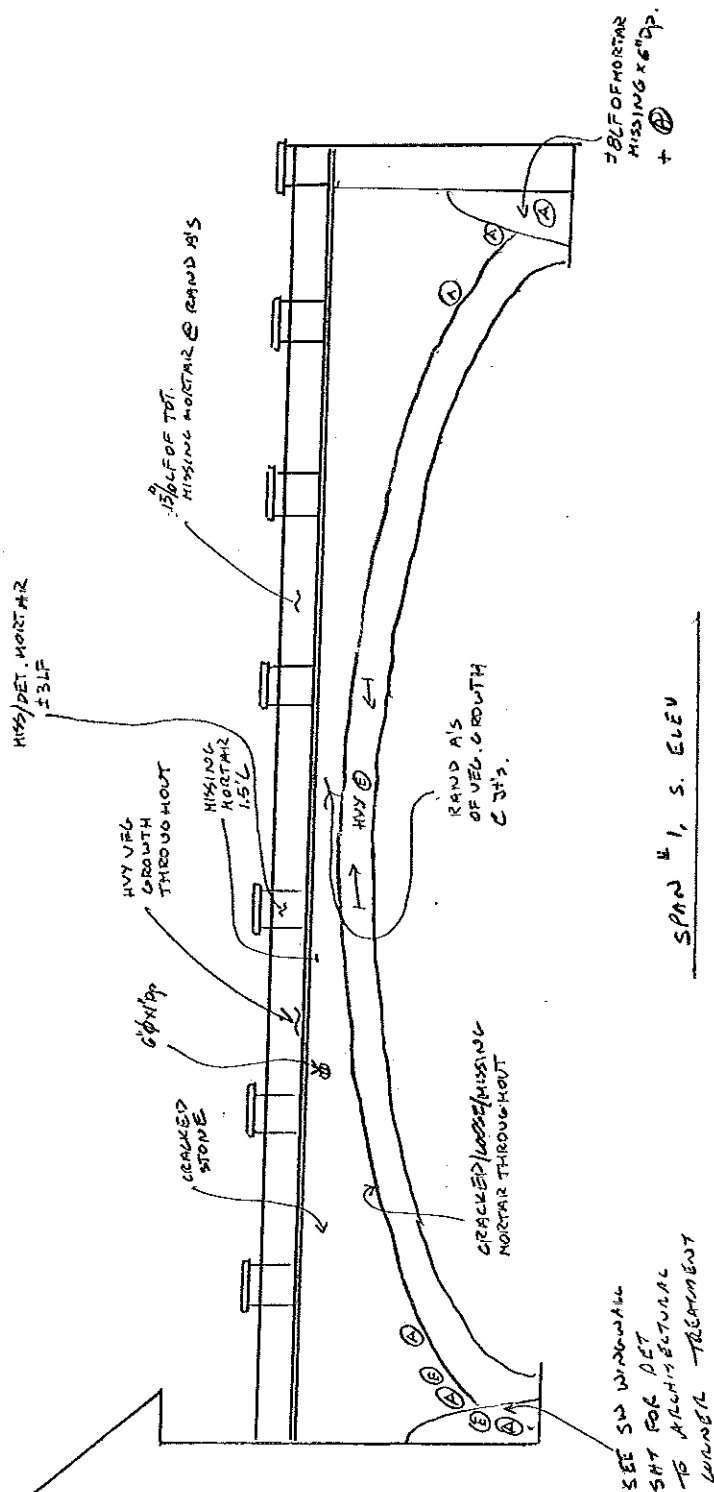
SPAN #1, S. ELEV

CBN. AREAS OF MISSING MORTAR TYP. 4"dp

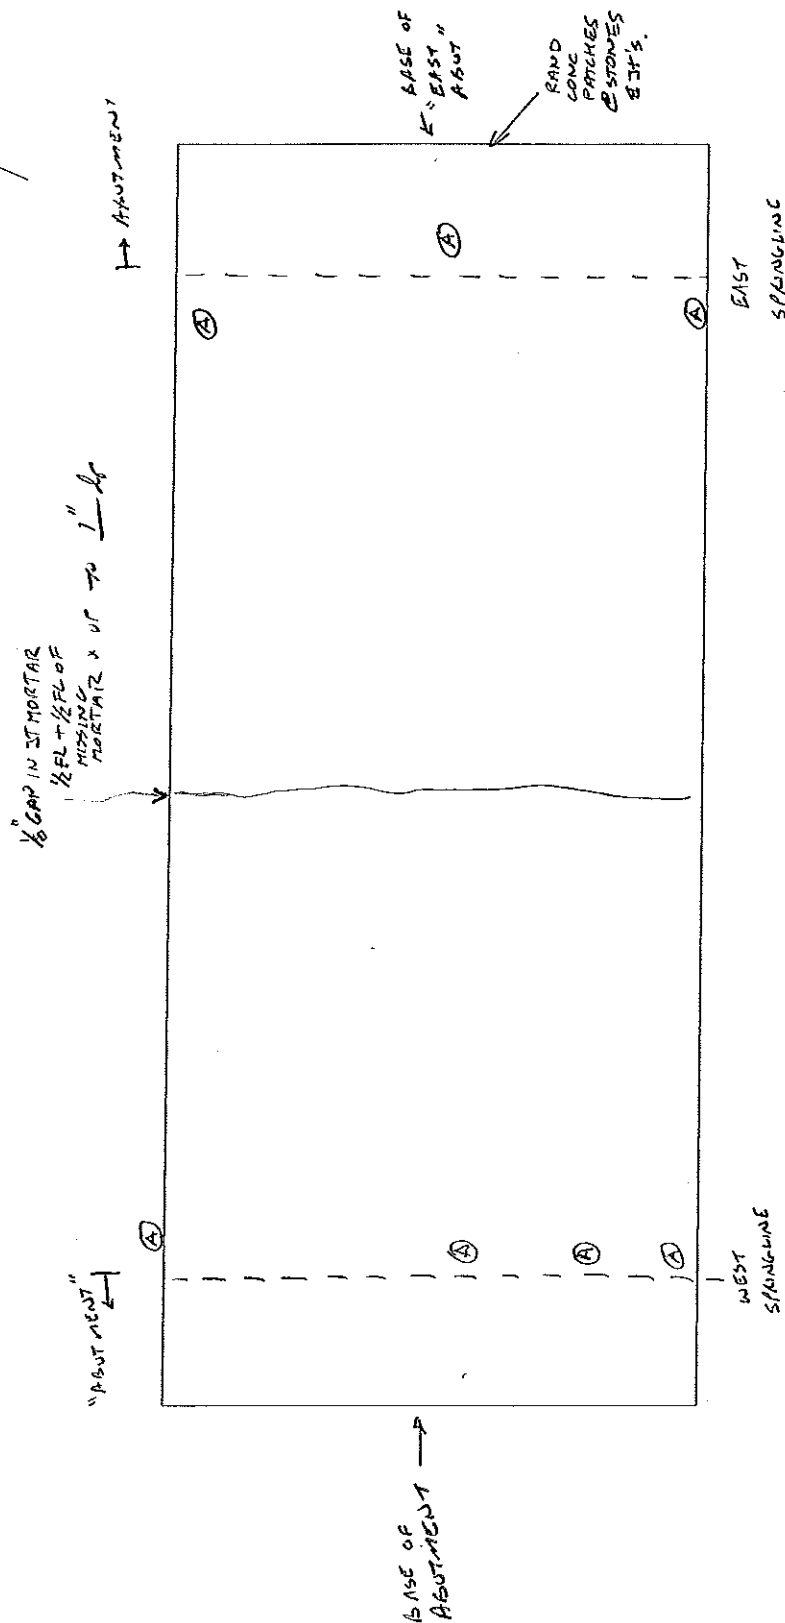
SPAN # 2 UNDERSIDE

① - ACTIVE LEAKAGE

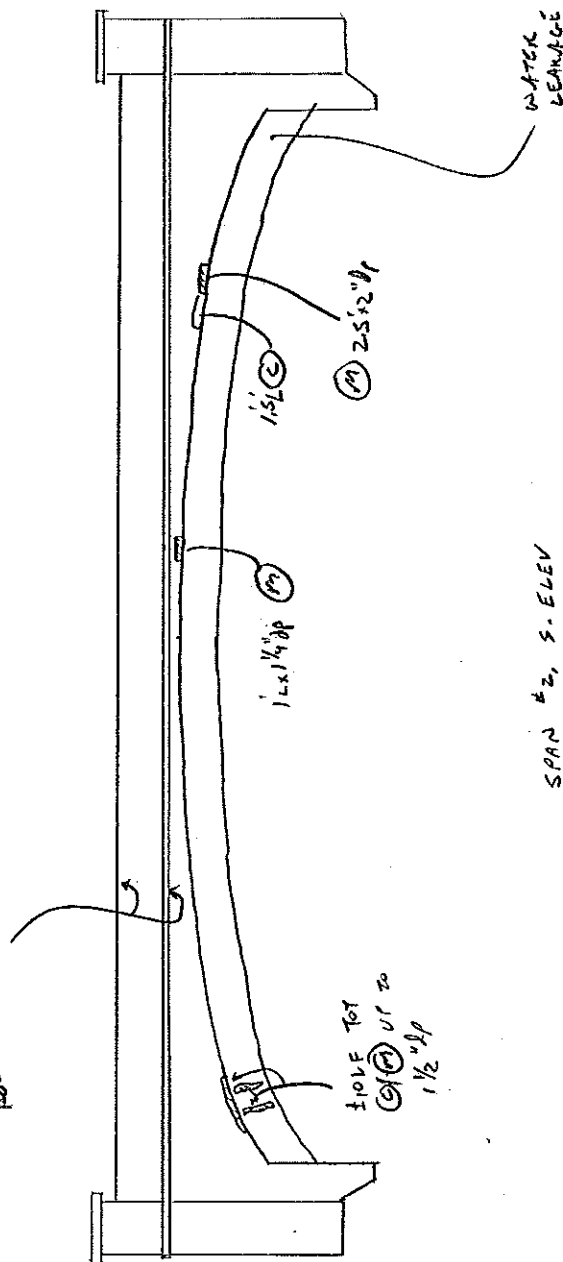
SPAN #2, S. ELEV

LAND CLWD MORTAR BELOW THIS ROW OF STONES, 7/16" - 1/8" W.

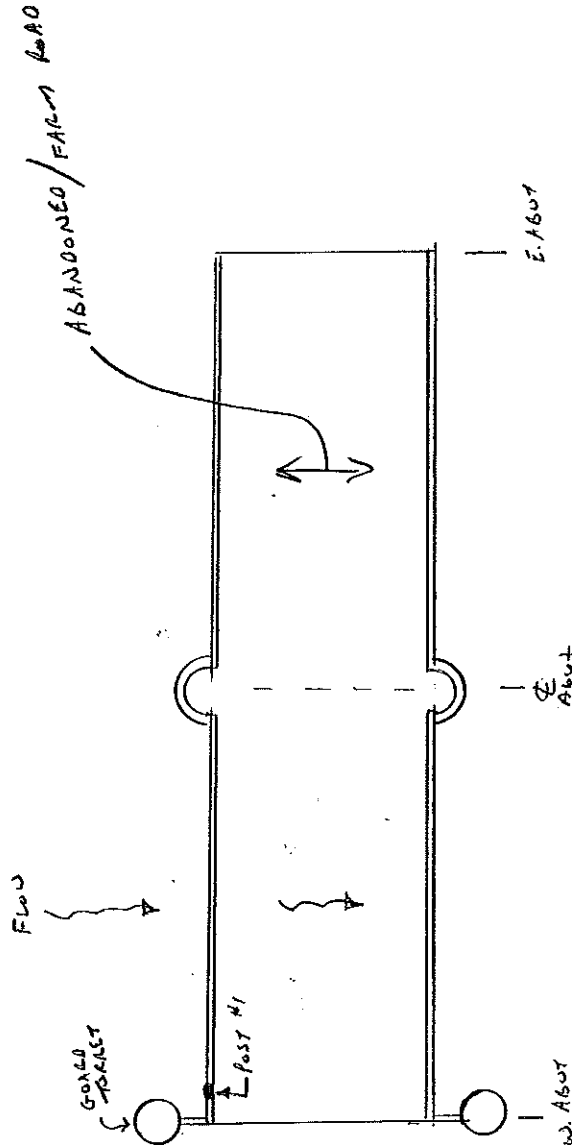
## PLAN VIEW

- ① ANY BRUSH OVERHANDS W/IN
- ② = SLOPE HOLE, ±20' x 20', ±3.5' d.p. (4.1' d.p. MAX WATER)
- ③ = 14'-RAD ELLIPSE
- ④ = LARGE HOLE OF FENCING

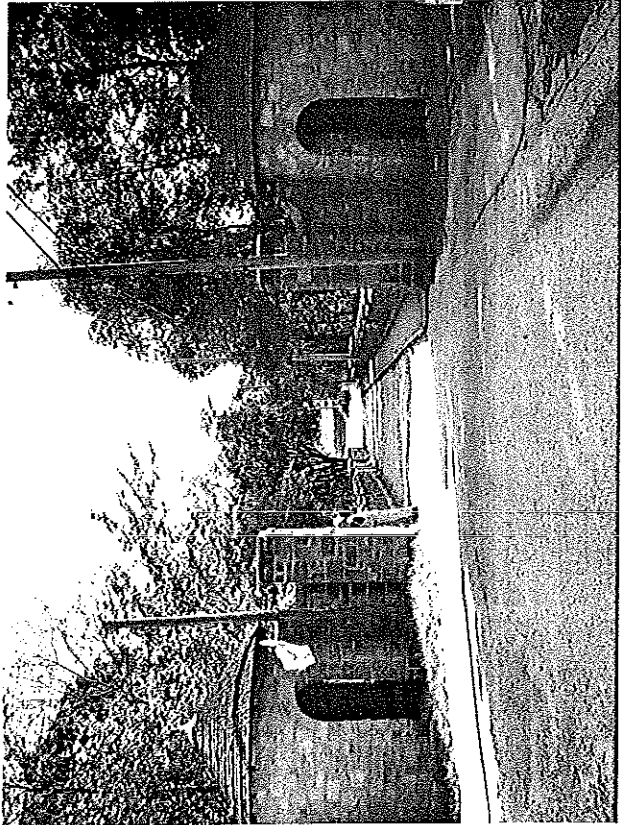
Stone masonry guard turrets at west approach: The north turret has a 2' x 1' missing section of roof. There are random deteriorated shakes along the roofs. There are sloppy mortar repairs at each turret, up to 5' high x 1' wide x 9" deep. There is random graffiti inside of the turrets. See sheets 11-12 and photos 5 & 13.

| <p>Photo # 5: Bridge from the west approach.</p> | <p>Photo # 6: Bridge from the east approach.</p> |

1. Seal the cracks and the sawcuts in the overlay ( $\pm 600$  linear feet).
2. Repair corner spalls in the granite curbs ( $< 1/4$  cubic yard).
3. Repair deteriorated mortar joints along the parapets ( $\pm 250$  linear feet).
4. Continue to monitor the tipping of the parapets.
5. Repair deteriorated roof shakes (as required) and missing section of roof sheathing ( $\pm 2$  square feet) at the guard turrets.
